# Coate Aer ATU Failure

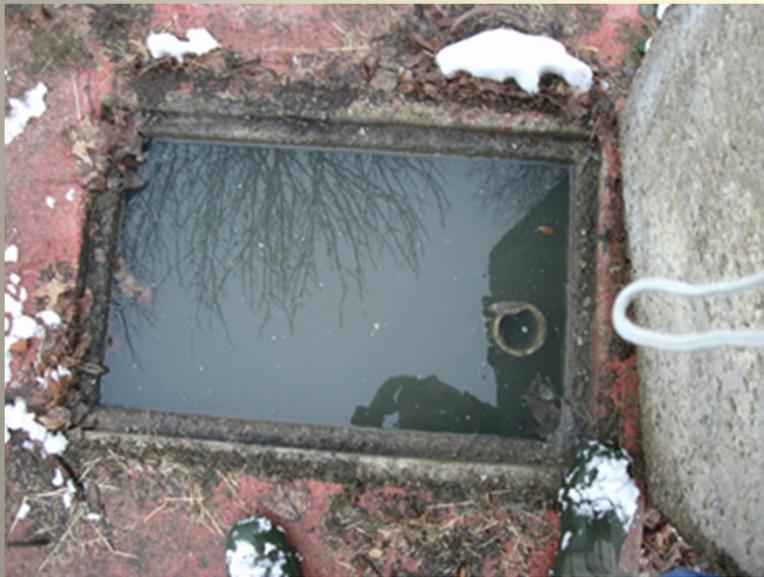
Water seeping to the surface of an exposed septic tank lid is a sign of a blocked drain. This is upflow filter that is not draining properly.

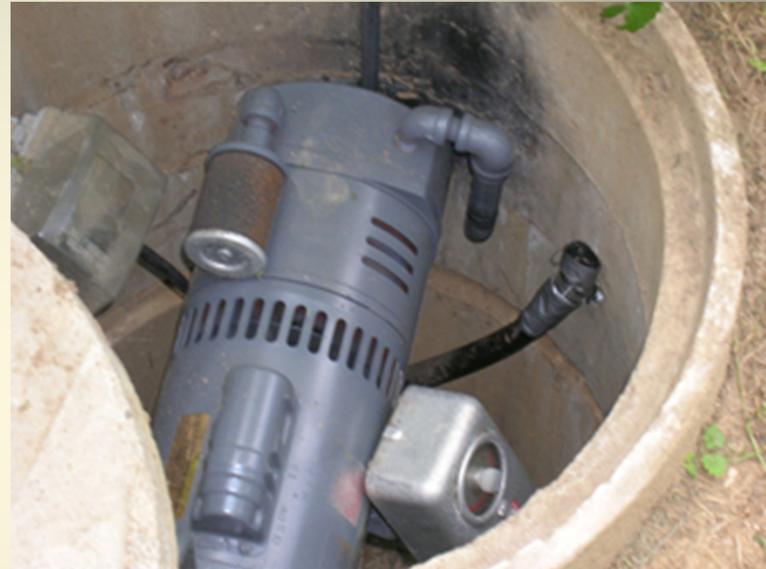
The airline to this motor has been disconnected. If the airline is not secure wastewater is not treated.

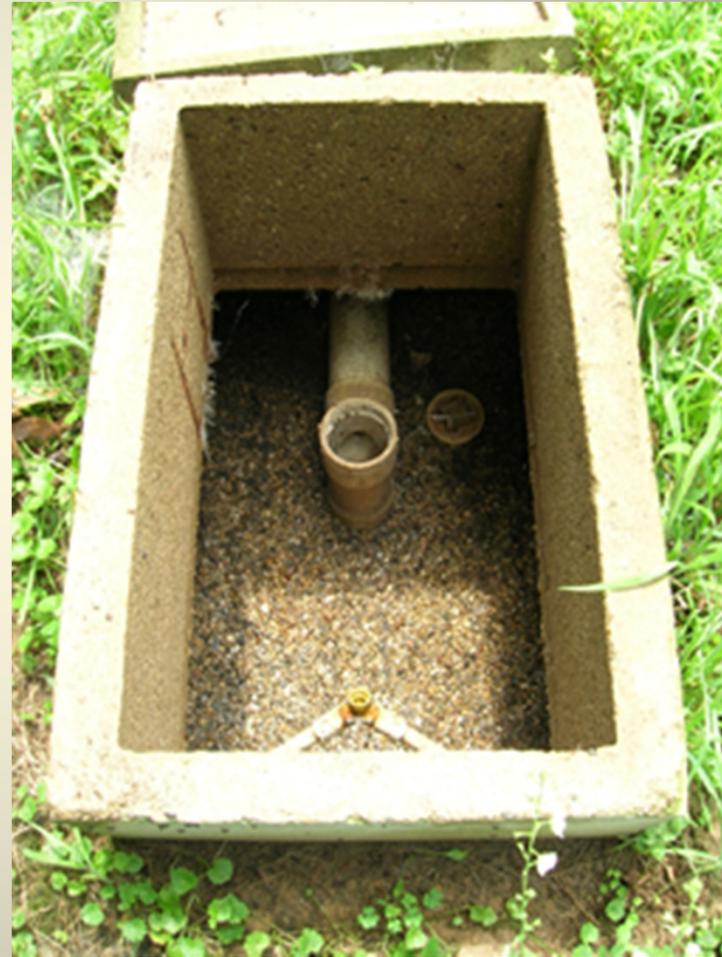
# Coate Aer ATU Repair

This is an upflow filter that is properly cleaned and functioning. Gravel is visible and no water is seeping to the surface.

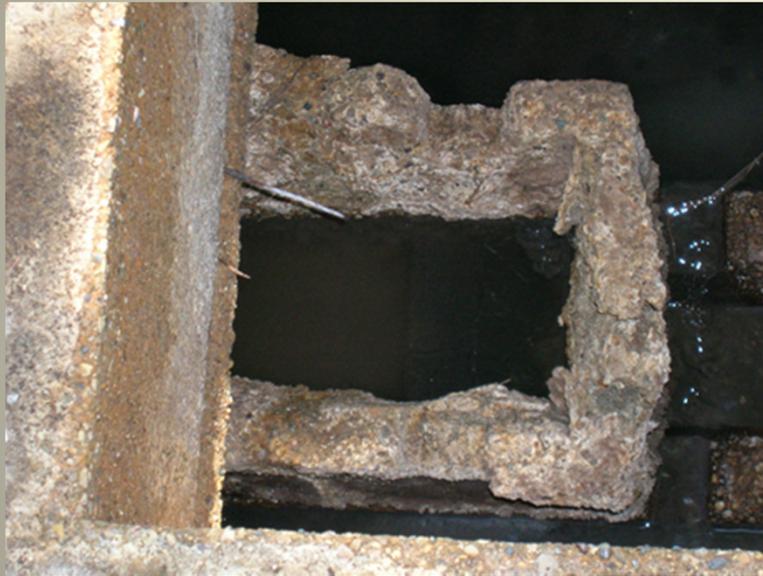
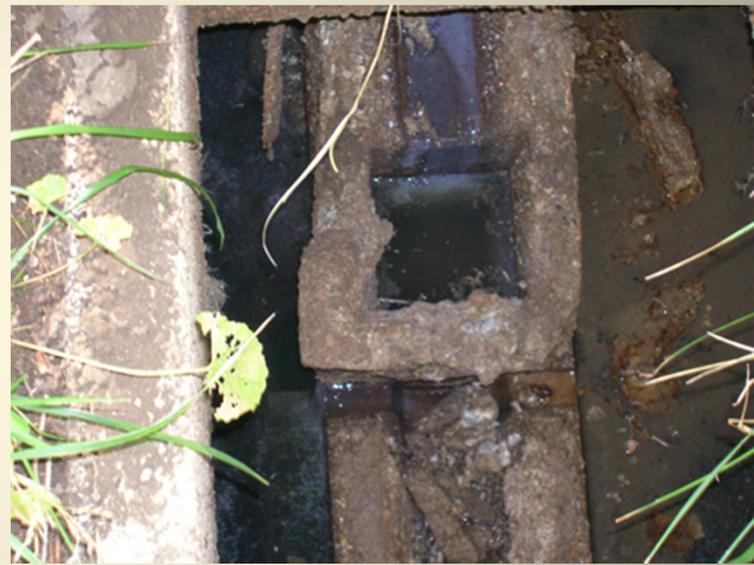
# Jet Inc. ATU Failure

Deteriorating walls is a common failure in upflow filters.

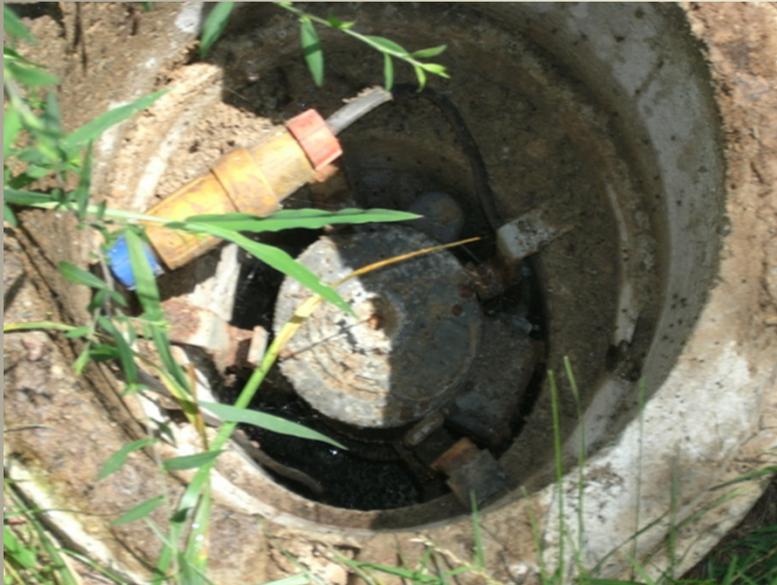
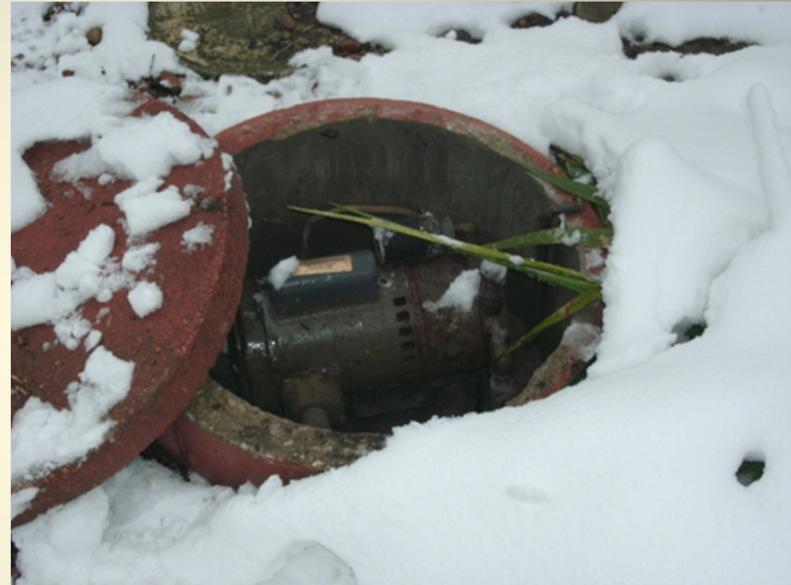
# Cold Motor

A motor that has not been running for a while will be cold to the touch and wet from condensation. Motors typically run on a thirty minute cycle; fifteen minutes on and fifteen minutes off. Some older systems have a motor with a twenty-four hour cycle. These motors should be set to pump during the day and rest at night.
